# A Carpenter's Study of the Chapter House Vestibule Door, Westminster Abbey

PETER MASSEY AND PAUL REED

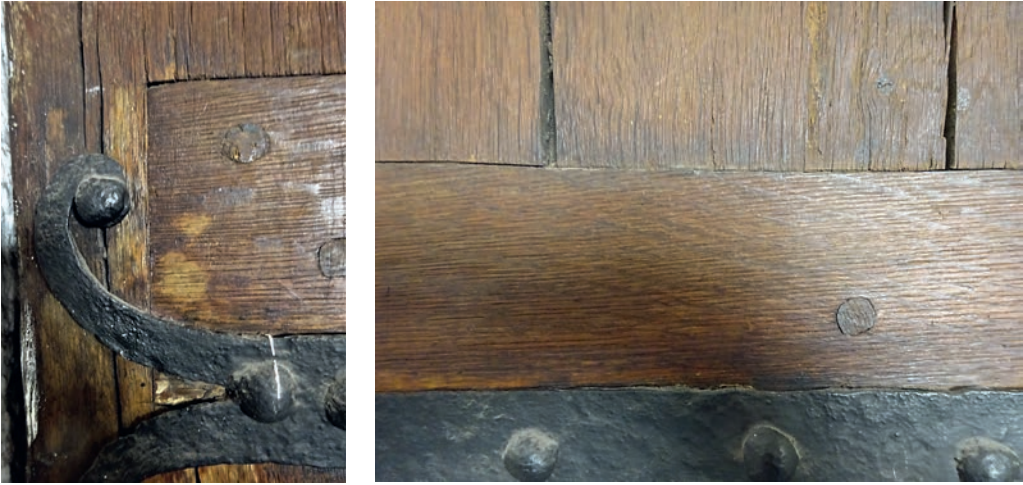
6 and 7 Details of the door, showing how neatly the ledge is let into the boards of the door.  
*Photo Paul Reed*

of string and a lath to make a bow. A large radius, described by Hewett, is not necessary.<sup>36</sup> The ledge board is cut to length with square ends using a handsaw. The bow is lined up on both ends of the ledge board and the radius is scored on the boards with a sharp knife (Figure 27). When both sides of the ledge board have been radius-scored, the waste is removed using a hand side axe (Figure 28). It could equally be removed using a saw (Figure 29). The edges are finished with a draw knife (Figure 30). Two holes are augered towards the ends of the ledge so that it can be securely held in place with temporary pegs and the boards of the door are scored with a sharp knife around the edges of the ledge to mark the area where it is to be let in. This has to be done very accurately so the ledge will fit tightly. On the original door, one can see where the carpenter has over-scored with his knife (Figure 6).

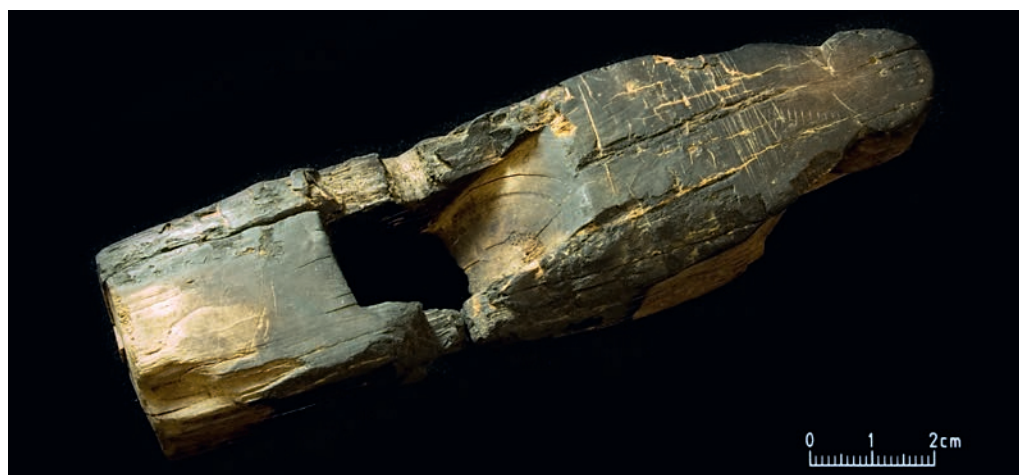
8 Ebbsfleet plane. Maidstone Borough Council: photo Robert J. Williams

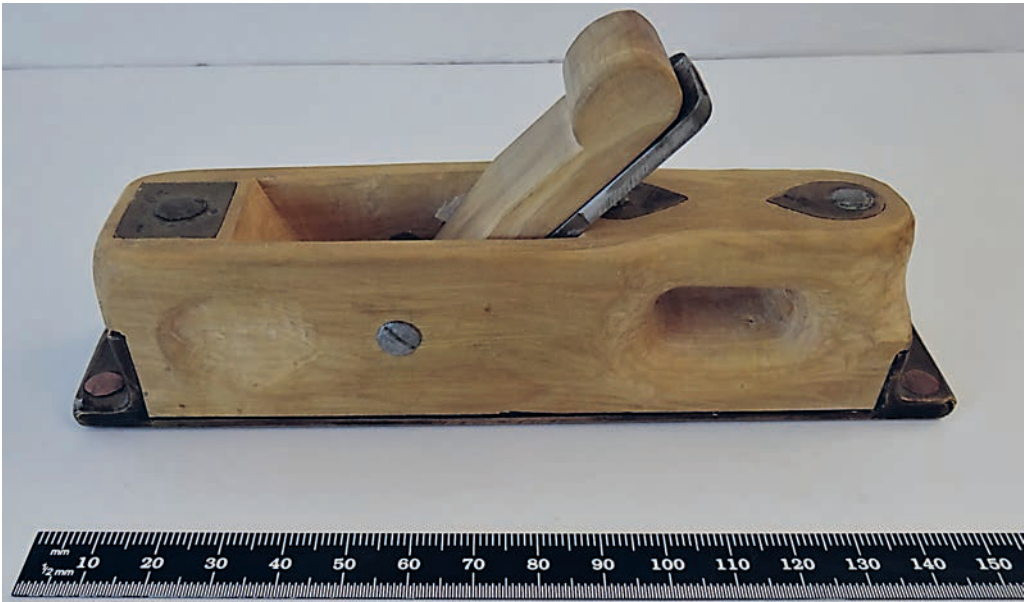
9 and 10 Replica of the Anglo-Saxon plane from Sarre, made by Peter Massey.  
*Photo Peter Massey*

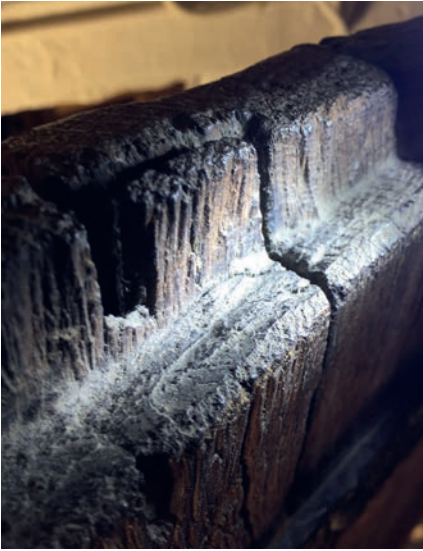
14 (left) Chisel marks on the top of the vestibule door. *Photo Paul Reed*

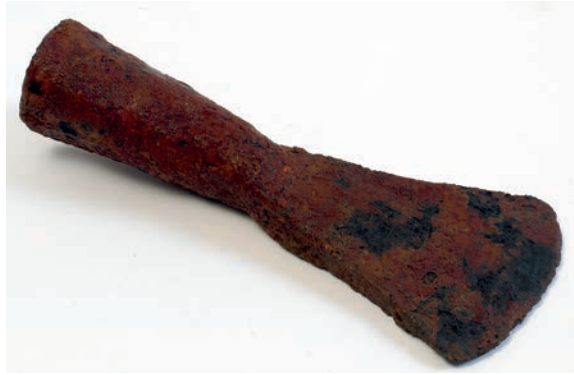
15 (above) Viking split-socketed iron chisel, excavated at Cleaves Farm, Skerne, 1982. *Hull & East Riding Museum, KINCM: 1984.58.3.*

Hull and East Riding Museum collection (Figure 15). This process is visible where the distinctive, slightly concave toolmarks pass over both boards, and is seen on both sides of the door (Figure 16). These tool marks have only survived through being protected by the hide or leather covering for hundreds of years.

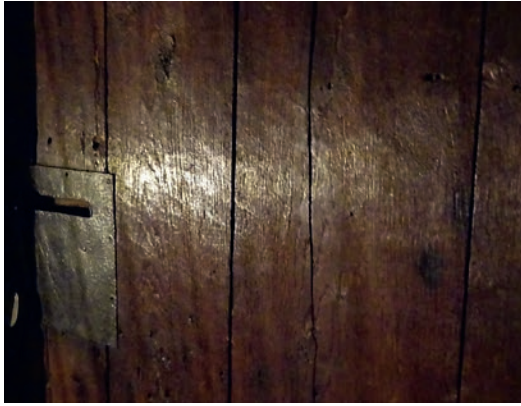
16 Tool marks seen going across the boards to remove the saw marks. *Photo Paul Reed*

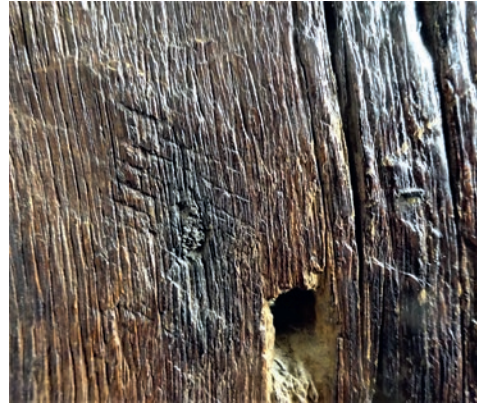
17 Saw marks missed by the finishing tool. *Photo Paul Reed*

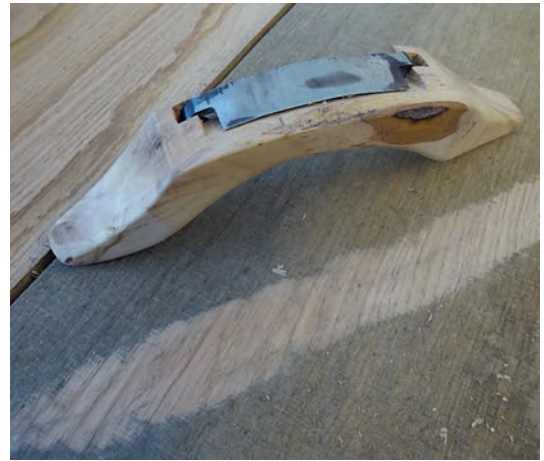
19 Shave made for the production of the replica door. *Photo Peter Massey*

bench, they are cleaned up using a shave to remove the saw marks on the surface of the planks (Figures 25 and 26). For this task Peter made a replica shave, adapting a modern shave by re-forging the modern blade into a shape that would replicate the historic tool marks on the original door (Figure 19).

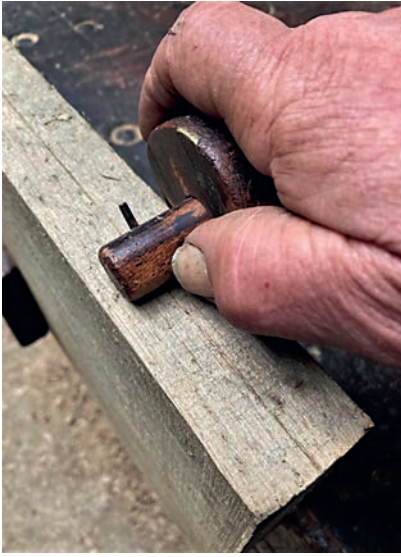
21 (far left) Setting out the rebates. *Photo E. Massey*

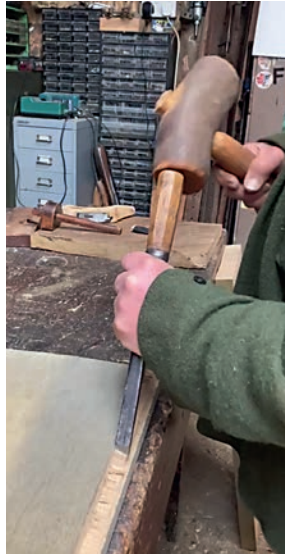
22 (left) Cutting out the rebates using a chisel. *Photo E. Massey*

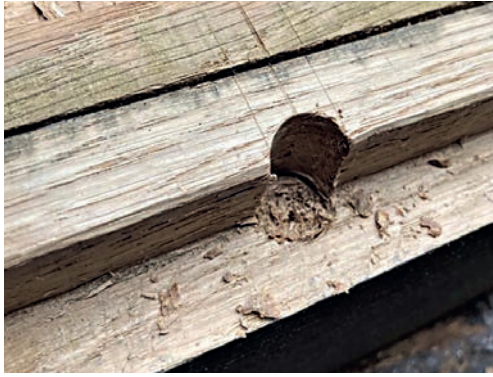
23 Setting out the location pegs.  
*Photo E. Massey*

The next stage is marking out the peg holes on the boards to be joined and inserting the location pegs (Figures 23 and 24). If set out accurately, the boards will fit perfectly, as seen on the original door. It was decided to cut the rebates first and then set out and sink the holes for the location pegs after the rebates were produced, as was done on the original door. However, it would be possible to sink the peg hole first before running out the rebates. Once the boards have been assembled and secured on the

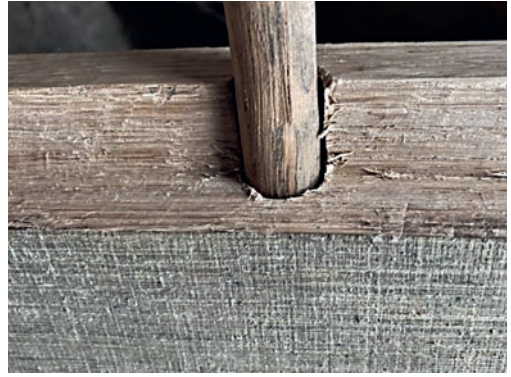
24 The peg hole is made with a shell auger to receive the location peg.  
*Photo by E. Massey*

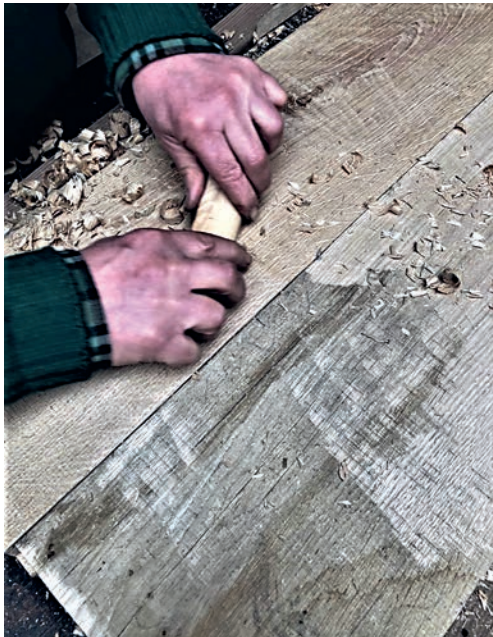
25 Shave in use. *Photo E. Massey*

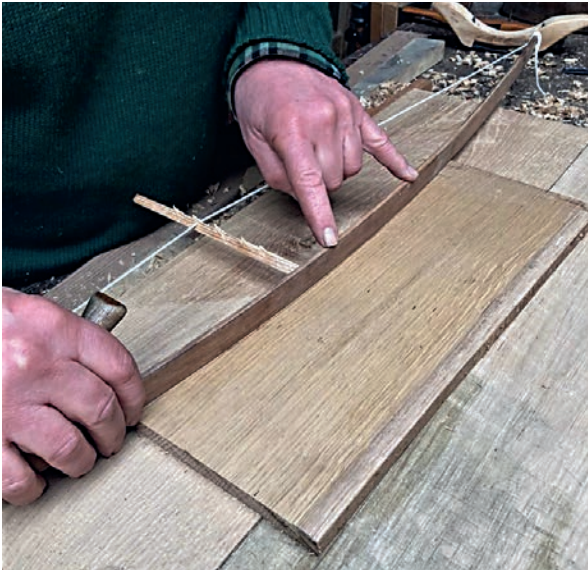
27 The radius is made with a bow and scored with a knife. *Photo E. Massey*

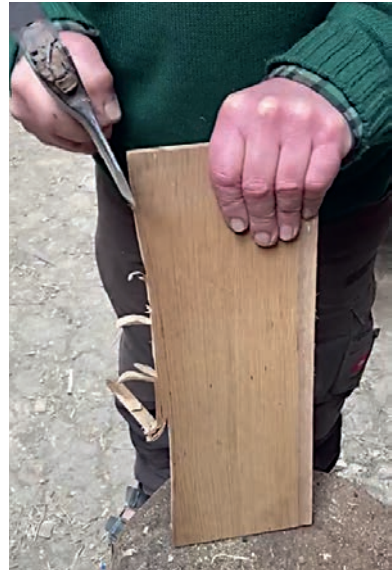
28 Waste is removed with a side axe. *Photo E. Massey*

to remove the saw marks from the face of the door (Figure 20), a drawknife (Figure 30), an adze, a hand side-axe (Figure 28), very likely a square for setting out boards and ledges, a flick line, an auger to make the peg holes and finally the use of a bench (Figure 5) or trestles in a workshop. For timber conversion the woodman would have needed a felling axe, a lopping axe and a frame saw that was used to saw the planks from the log, probably on trestles or over a saw-pit or by adopting the see-saw method following the flick line as a guide. The rake of the saw marks on the door boards is about 55°, as found on see-sawn timbers.<sup>40</sup> For lifting heavy logs or timbers, pulleys and ropes would have been required. Taken together this represents a very good toolkit indeed for a carpenter. We believe our study provides compelling evidence that Anglo-Saxon carpenters were highly skilled craftsmen, who were more than capable of precision setting out and assembly, and making and adapting tools to do specific jobs, as demonstrated by Peter Massey in making the replica sample of the vestibule door.

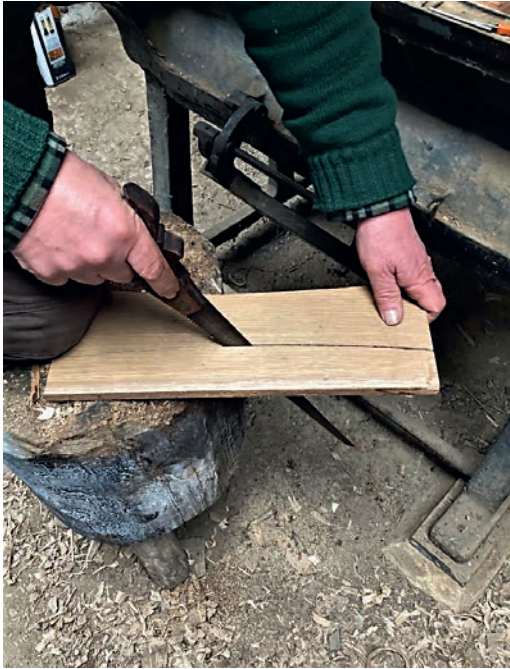
29 Cutting out the waste using a saw.  
*Photo E. Massey*

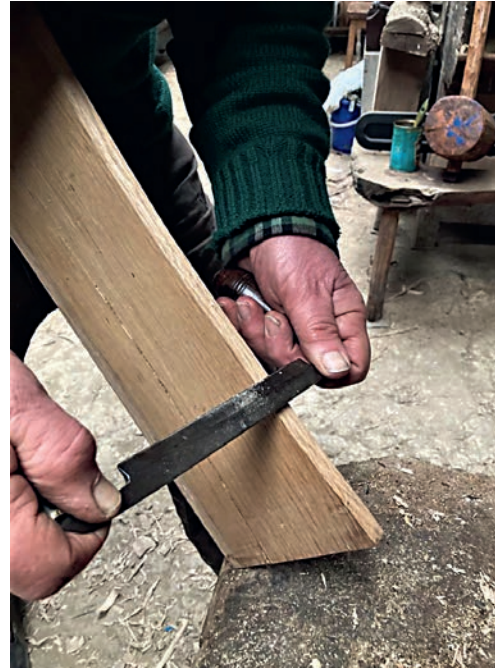
30 Truing up the edges with a draw knife.  
*Photo E. Massey*

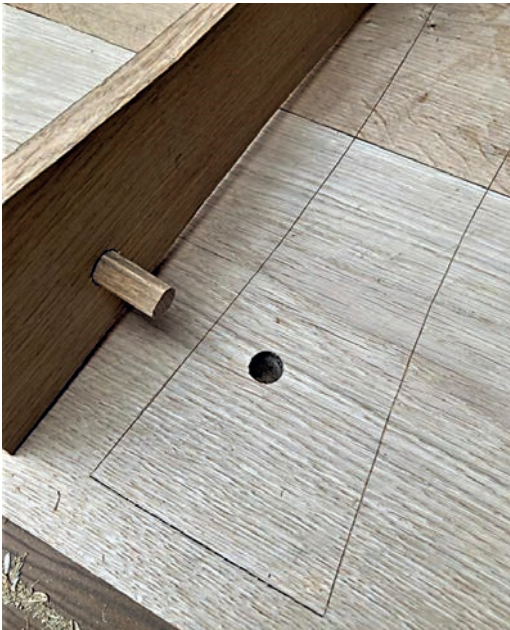
31 Showing the scored outline of the ledge.  
*Photo E. Massey*

The ledge is removed (Figure 31) and the edge of the housing is carefully cut following the scored line, and the remaining waste is removed with the chisel (Figure 32). When all the waste has been removed, a router is used to cut out the bottom of the housing to the required depth. Peter used a granny-tooth router with a narrow blade (Figure 34). A sample of the ledge, a small piece of the same thickness, is used to check the depth of the housing. The marks of the router can be clearly seen on the original door (Figure 33). Finally, letting in the ledge, it has to fit perfectly as it would be impossible to remove for the purposes of adjustment without damaging the edges of the housing; fit once – precision carpentry.

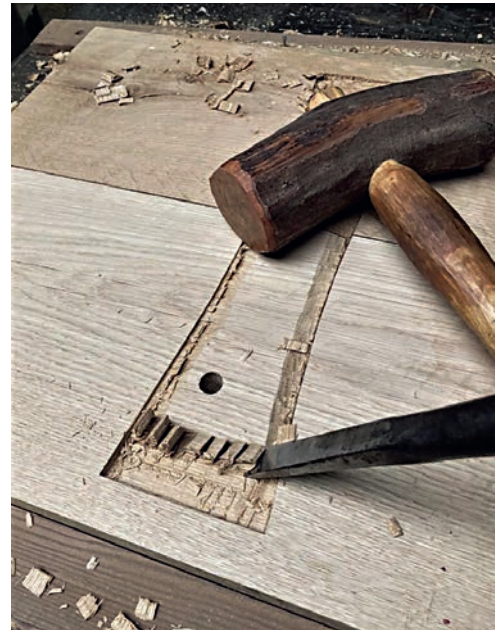
32 Cutting out the housing with a chisel.  
*Photo E. Massey*

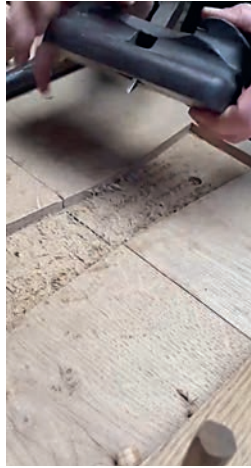
34 (middle) Routing out the housing. *Photo E. Massey*

The recessed edges of the housing have been formed using a chisel and a router (Figures 12 and 34). There is no evidence of a Saxon router, but the Vikings did use a grooving/moulding iron, similar in shape to a drawknife, to make the depth of the housing floor base consistent and flat (Figure 13).<sup>22</sup> This flat surface is seen at the top of the door where the ledge has been removed (Figure 14 and 33). The carpenter has fitted the ledges very precisely; even today there is no gap between the ledge and the boards of the door (Figures 6 and 7). Once the ledge was let into the door, the remaining pegs were inserted into the ledges and boards. The door was then turned over on the bench and the two remaining ledges were fixed as described above. We could find no end-wedging to the pegs securing the ledges, as shown in Cecil Hewett's

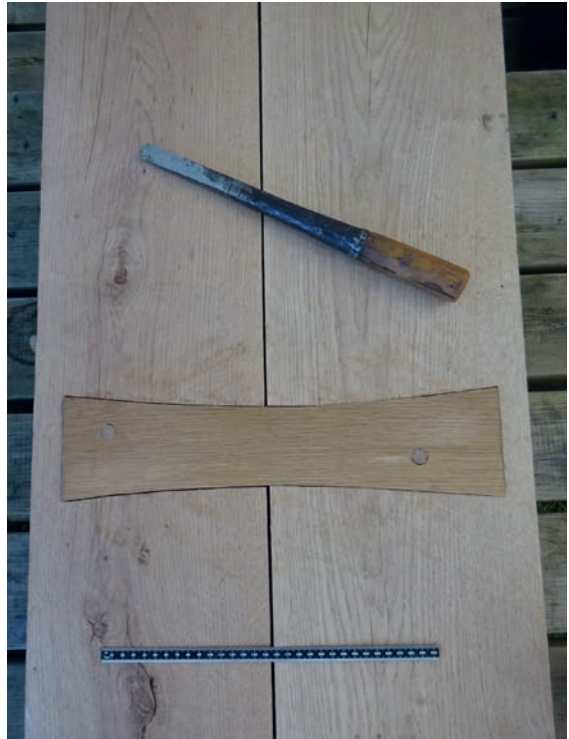
36 Completed replica sample of the vestibule door by Peter Massey.  
*Photo E. Massey*
